Smith
Simmons
& Partners

PRE-CONSTRUCTION INFORMATION PACK

Chichester Harbour Conservancy

Refurbishment of existing shower block and kit room

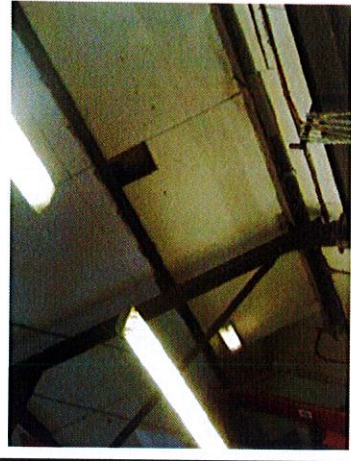
Item No	001	Location No	G.01	Location	Workshop
Description	Fibre board to ceiling	Product	Damage	Surface Treatment	Asbestos Type
Management Option	N/A	N/A	N/A	N/A	N.A.D.I.S
Comments	Extent >40 M2 Repair/Encapsulate Broken Edges

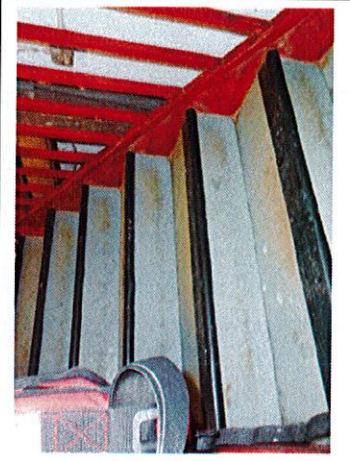
Item No	002	Location No	G.01	Location	Workshop
Description	Stair nosing	Product	Damage	Surface Treatment	Asbestos Type
Management Option	N/A	N/A	N/A	N/A	N.A.D.I.S
Comments	Extent 14 LM

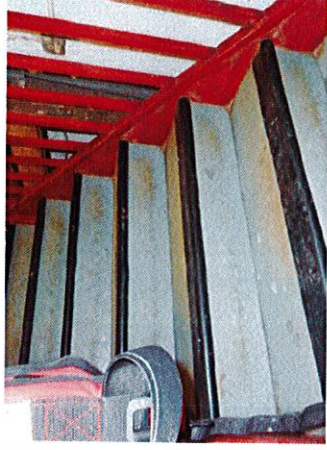
Item No	003	Location No	G.01	Location	Workshop
Description		Product	Damage	Surface Treatment	Asbestos Type
Lino to stairs	N/A	N/A	N/A	N/A	N.A.D.I.S
Management Option	N/A	Extent	5	M2	
Comments

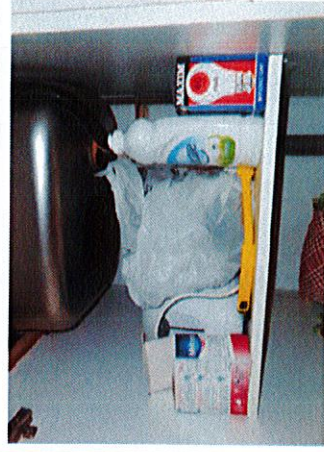
Item No	004	Location No	1.09	Location	Kitchen
Description		Product	Damage	Surface Treatment	Asbestos Type
Sink pad	N/A	N/A	N/A	N/A	N.A.D.I.S
Management Option	N/A	Extent	1	Item	
Comments

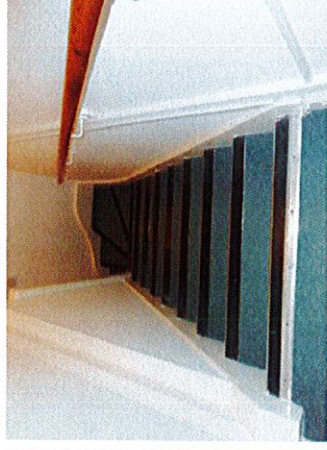
Item No	005	Location No	1.10	Location	Corridor 2
Description	Stair nosing	Product	Damage	Surface Treatment	Asbestos Type
				N/A	N/A
Management Option	N/A	N/A	Extent	14	1M
			Comments

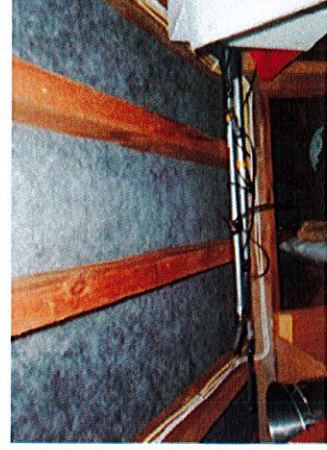
Item No	006	Location No	2.01	Location	Landing
Description	Roof felt in cupboard	Product	Damage	Surface Treatment	Asbestos Type
				N/A	N/A
Management Option	N/A	N/A	Extent	10	M2
			Comments

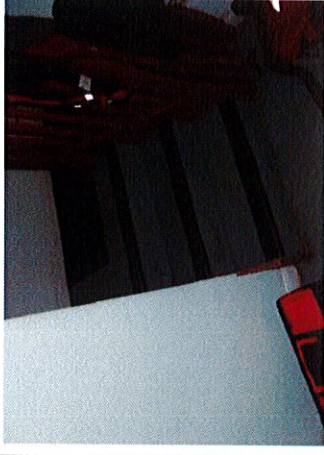
Item No	AS 002	Location No	1.01	Location	Corridor 1	
Description	Stair nosing	Product	Damage	Surface Treatment	Asbestos Type	
					N/A	N/A
Management Option	N/A	Extent	4	1.M		
Comments

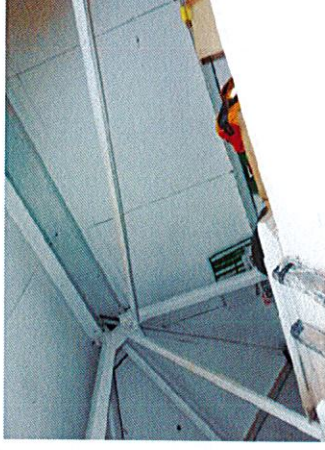
Item No	AS 001	Location No	1.02	Location	Locker room
Description	Fibre board to ceiling	Product	N/A	Damage	Asbestos Type
Management Option	N/A	Extent	>20	Surface Treatment	N.A.D.I.S
Comments	Repair/Encapsulate Broken Edges

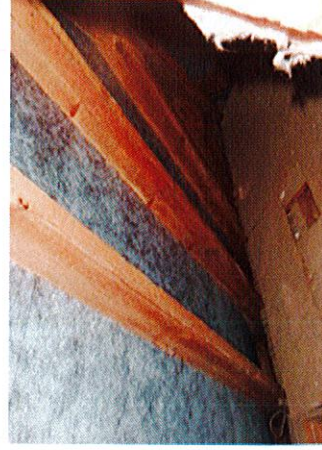
Item No	AS 006	Location No	2.03	Location	Top floor
Description	Roof felt in cupboard	Product	N/A	Damage	Asbestos Type
Management Option	N/A	Extent	4	Surface Treatment	N.A.D.I.S
Comments

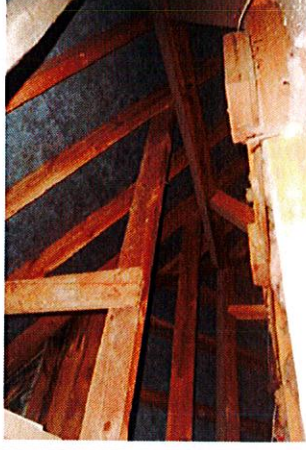
Item No	AS 006	Location No	L.01	Location	Loft
Description	Roof felt	Product	Damage	Surface Treatment	Asbestos Type
		N/A	N/A	N/A	N.A.D.I.S
Management Option		N/A	Extent	M2	
Comments

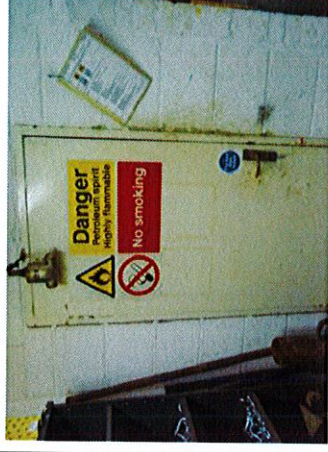
Item No	VIS 002	Location No	G.02	Location	Paint Store
Description	Fire door	Product	Damage	Surface Treatment	Asbestos Type
Management Option	2 - Medium (AIB, Textiles, Gaskets)	Label & Manage	0 - No Damage	1-Low (Cement, Painted AIB, Enclosed Lagging)	Amphibole Excluding Crocidolite Presumed
Comments			Extent	Item	
			1

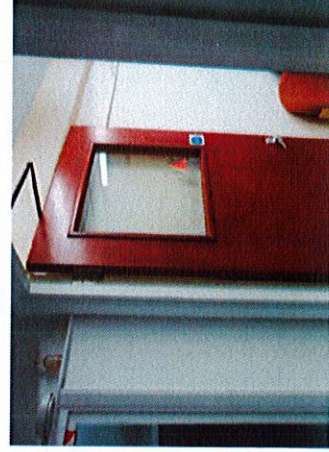
1.01	Corridor 1	VIS 003	Fire door	2 - Medium (AIB, Textiles, Gaskets)	0 - No Damage	1 - Low (Cement, Painted AIB, Enclosed Lagging)	Amphibole Excluding Crocidolite Presumed	Label & Manage	4 Item

Item No	VIS 003	Location No	1.01	Location	Corridor 1
Description	Fire door	Product	Damage	Surface Treatment	Asbestos Type
Management Option	2 - Medium (AIB, Textiles, Gaskets)	Label & Manage	0 - No Damage	1-Low (Cement, Painted AIB, Enclosed Lagging)	Amphibole Excluding Crocidolite Presumed
Comments			Extent	Item	
			4

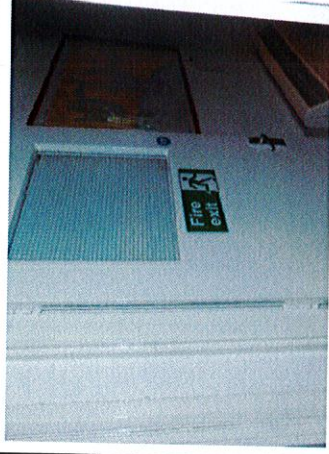
1.10	Corridor 2	VIS 004	Fire door	2 - Medium (AIB, Textiles, Gaskets)	0 - No Damage	1 - Low (Cement, Painted AIB, Enclosed Lagging)	Amphibole Excluding Crocidolite Presumed	Label & Manage	4 Item

Item No	VIS 004	Location No	1.10	Location	Corridor 2
Description	Fire door	Product	Damage	Surface Treatment	Asbestos Type
Management Option	2 - Medium (AIB, Textiles, Gaskets)	Label & Manage	0 - No Damage	1-Low (Cement, Painted AIB, Enclosed Lagging)	Amphibole Excluding Crocidolite Presumed
Comments			Extent	Item	
			4

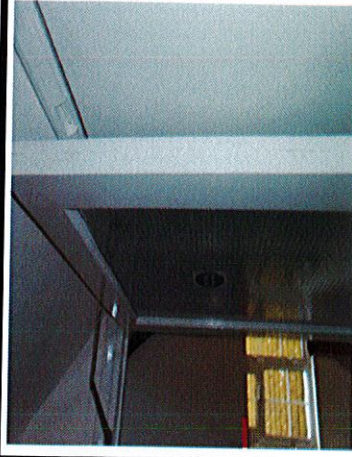
Item No	VIS 005	Location No	2.01	Location	Landing
Description	Fire door	Product	Damage	Surface Treatment	Asbestos Type
Management Option	2 - Medium (AIB, Textiles, Gaskets)	Label & Manage	0 - No Damage	1-Low (Cement, Painted AIB, Enclosed Lagging)	Amphibole Excluding Crocidolite Presumed
Comments			Extent	Item	
			1

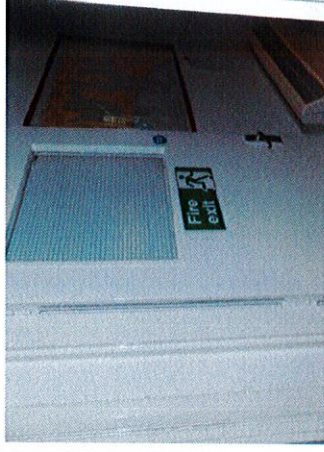
Item No	VIS 006	Location No	G.05	Location	Admin office
Description	Fire door	Product	Damage	Surface Treatment	Asbestos Type
Management Option	2 - Medium (AIB, Textiles, Gaskets)	Label & Manage	0 - No Damage	1 - Low (Cement, Painted AIB, Enclosed Lagging)	Amphibole Excluding Crocidolite Presumed
Comments			Extent	Item	
			1

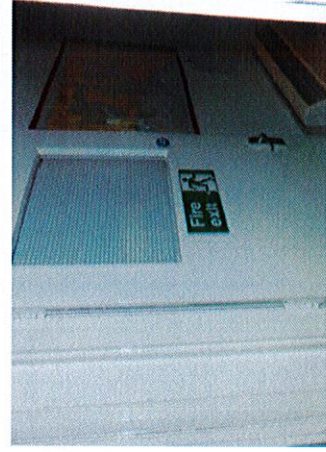
Item No	VIS 007	Location No	G.10	Location	Reception
Description	Fire door	Product	Damage	Surface Treatment	Asbestos Type
Management Option	2 - Medium (AIB, Textiles, Gaskets)	Label & Manage	0 - No Damage	1 - Low (Cement, Painted AIB, Enclosed Lagging)	2 - Amphibole Excluding Crocidolite
Comments			Extent	Item	
			3

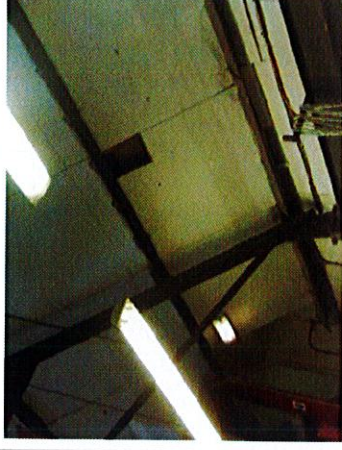
Item No	VIS 008	Location No	G.01	Location	Workshop
Description		Product	Damage	Surface Treatment	Asbestos Type
Cement above fibre board	1- Low (Plastics, Resins, Mastics)		0 - No Damage	1 - Low (Cement, Painted AIB, Enclosed Lagging)	Chrysotile Presumed
Management Option	Label & Manage	Extent	>10	M2	
Comments

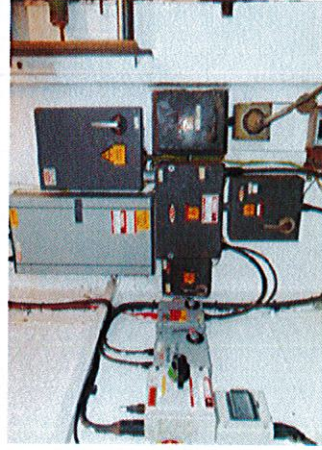
Item No	NO ACCESS	Location No	G.01	Location	Workshop
Description		Product	Damage	Surface Treatment	Asbestos Type
Fuse boxes live	Unknown		Unknown	Unknown	Unknown
Management Option	Exercise Caution	Extent	5	Item	
Comments

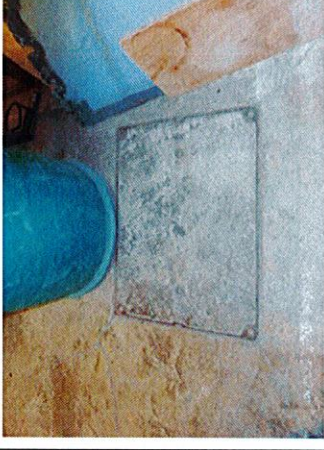
Item No	NO ACCESS	Location No	G.02	Location	Paint Store
Description		Product	Damage	Surface Treatment	Asbestos Type
Man hole cover sealed		Unknown	Unknown	Unknown	Unknown
Management Option		Exercise Caution	Extent	1	Item
Comments

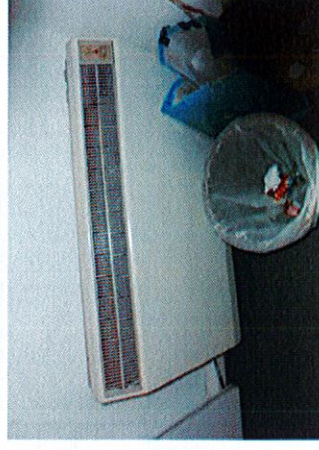
Item No	NO ACCESS	Location No	1.04	Location	Patrol office
Description		Product	Damage	Surface Treatment	Asbestos Type
Storage heater		Unknown	Unknown	Unknown	Unknown
Management Option		Exercise Caution	Extent	1	Item
Comments

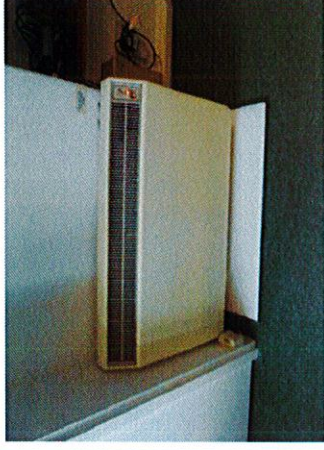
Item No	NO ACCESS	Location No	1.07	Location	Harbour master office	
Description		Product	Damage	Surface Treatment	Asbestos Type	
Storage heater		Unknown	Unknown	Unknown	Unknown	
Management Option		Exercise Caution	Extent	Item		
			1			
Comments

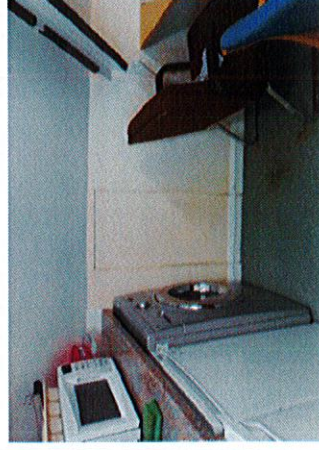
Item No	NO ACCESS	Location No	1.03	Location	Staff room	
Description		Product	Damage	Surface Treatment	Asbestos Type	
Access panel sealed		Unknown	Unknown	Unknown	Unknown	
Management Option		Exercise Caution	Extent	Item		
			1			
Comments

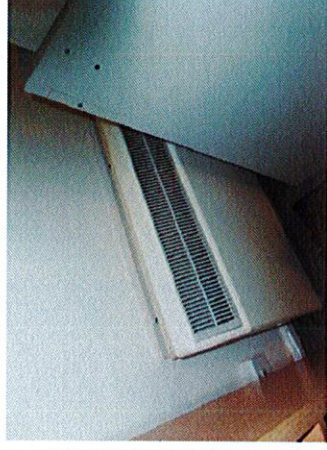
Item No	NO ACCESS	Location No	2.03	Location	Top floor
Description		Product	Damage	Surface Treatment	Asbestos Type
Storage heater	Unknown	Unknown	Unknown	Unknown	Unknown
Management Option	Exercise Caution	Extent	1	Item	
Comments

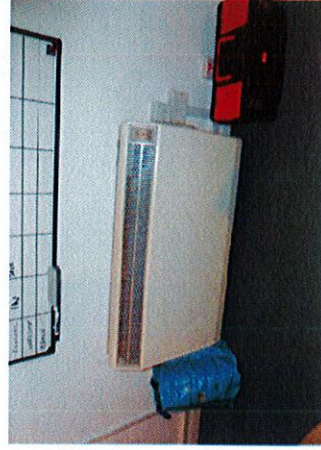
Item No	NO ACCESS	Location No	G.09	Location	Office
Description		Product	Damage	Surface Treatment	Asbestos Type
Storage heater	Unknown	Unknown	Unknown	Unknown	Unknown
Management Option	Exercise Caution	Extent	1	Item	
Comments

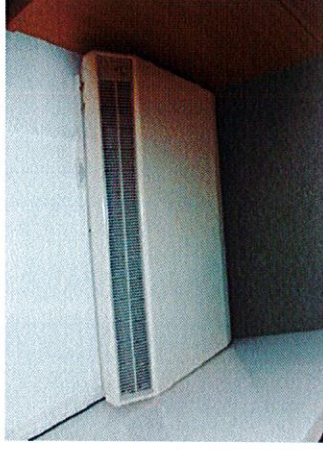
Item No	NO ACCESS	Location No	G.10	Location	Reception
Description		Product	Damage	Surface Treatment	Asbestos Type
Storage heater		Unknown	Unknown	Unknown	Unknown
Management Option		Exercise Caution	Extent	Item	
			1		
Comments

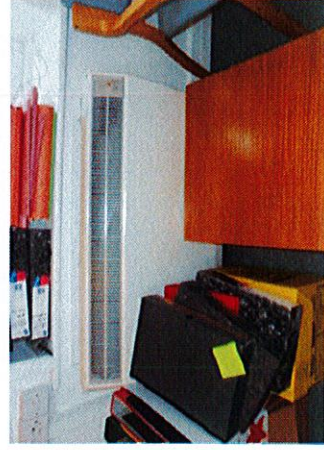
Item No	NO ACCESS	Location No	G.05	Location	Admin office
Description		Product	Damage	Surface Treatment	Asbestos Type
Storage heater		Unknown	Unknown	Unknown	Unknown
Management Option		Exercise Caution	Extent	Item	
			1		
Comments

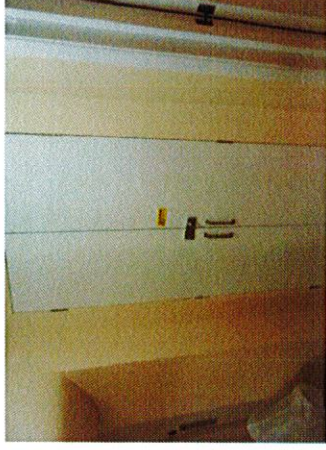
Item No	NO ACCESS	Location No	G.13	Location	Shows
Description	Product	Damage	Surface Treatment	Asbestos Type	
Electric cupboard locked	Unknown	Unknown	Unknown	Unknown	
Management Option	Exercise Caution	Extent	1	Item	
Comments
